**Design And Performance Of Earth  
Retaining Structures**

**Design And Performance Of A  
Deep Excavation Support System  
In Boston, Massachusetts**

Robert C. Houghton, MASCE

Schnabel Foundation Company

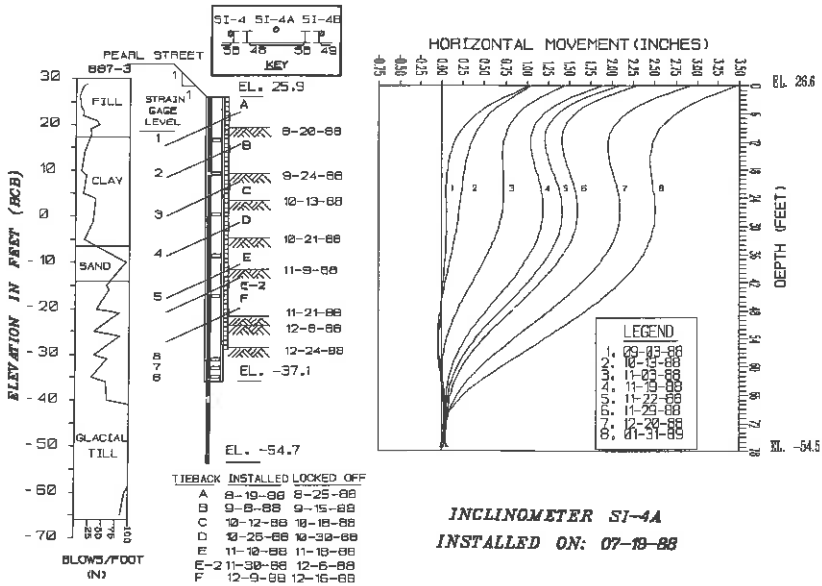
FIGURE 5a: LATERAL MOVEMENT FOR SOLDIER PILE 49

Figures 6 and 7 indicate the lateral movement that occurred during excavation on Pearl Street and High Street respectively. The magnitude of ground movement on Pearl Street was several times that observed on the High Street side.

The Pearl Street inclinometers (Figure 6) show successive bulges in lateral movement as each new cut was made. The magnitude of building settlement also increased as each new lift was excavated. The lateral movement peaks at approximately 2 3/4 inches. The load cell readings (Figure 9), however, generally show an initial loss of load followed by little or no load increase with time. Because of the observed difference in performance between High Street and Pearl Street, and the apparent inconsistency of increasing lateral deflection without accompanying load increase in the tiebacks, it was decided to obtain additional subsurface information.

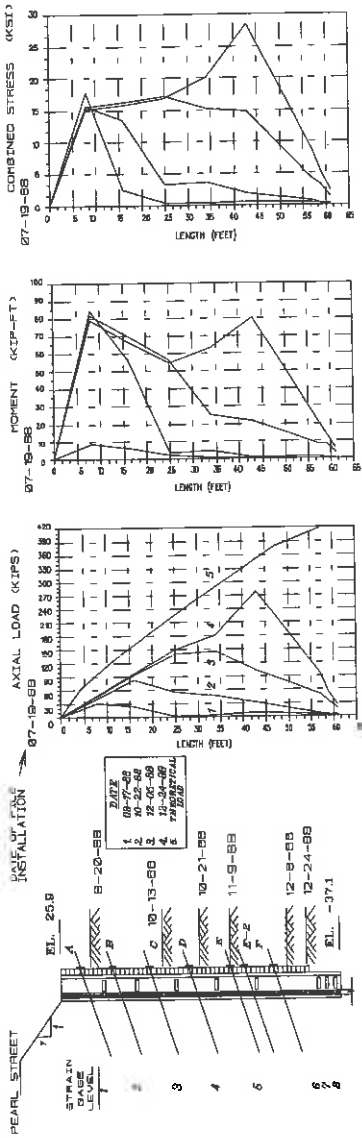
FIGURE 8a. STRAIN ANALYSIS FOR SOLDIER PILE #8

The axial load, moment and combined stress as computed from the strain gage readings are plotted for two piles in Figure 8. A family of plots representing information gathered at different times in the excavation sequence is presented for each parameter.

The combined stress plot (Figure 8a) for soldier pile 48 shows higher than expected stress levels (approximately 30 ksi) above subgrade level. The mass movement apparently affects the piles differently at different levels as the piles adjust to the ground movement. Stresses in the lower portions of pile 48 are much less, and the magnitude of lateral movement is also less. Combined stresses in the High Street pile (67) show values peaking at less than 20 ksi (Figure 9b).

One of the prime reasons for instrumenting the piles is to analyze the load distribution in the pile toes to verify design assumptions. The axial load distribution computed from the strain gages in the soldier piles is shown in Figures 8a and 8b along with the theoretical maximum axial load line derived by summing the vertical components of the tieback load with depth. The data clearly indicates that the axial load dissipates before the toe of the pile is reached.

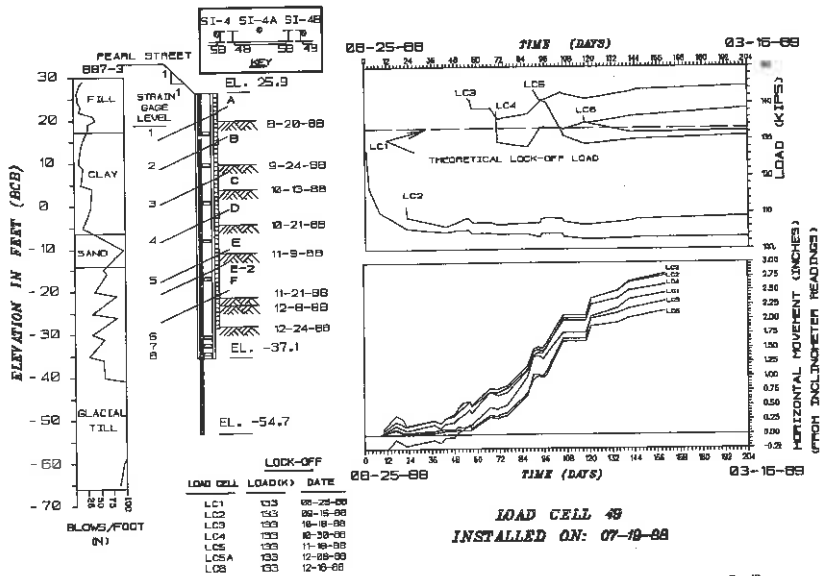
FIGURE 9a: HORIZONTAL MOVEMENT AND LOADCELL INSTRUMENTATION FOR SOLDIER PILE 49

The contradictory behavior of increasing deflection with decreasing tieback load build-up (Figure 9) provides an interesting dilemma. The most likely explanation is that a mass stability type movement occurred. Figure 10 shows the assumed failure plane used for design. On all streets except Pearl Street the tiebacks were anchored exclusively in the till. On Pearl Street a different set of soil conditions was encountered. The "glacio-marine" clay layer was found

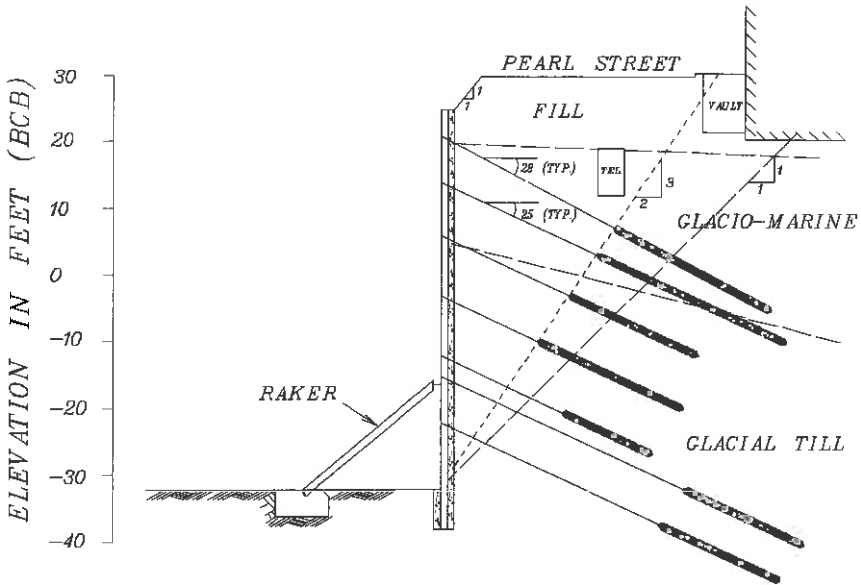
**FIGURE 10: TYPICAL CROSS-SECTION OF PEARL STREET**

Extra tiebacks and rakers (44, 46, 51, and 53) were installed in the northerly portion of Pearl Street (see Figure 10 for location) before the subgrade elevation was reached. Data from strain gages installed on these rakers also show that increasing load was experienced by

the rakers as the excavation proceeded to subgrade. The magnitude of loads summarized in Table 3 are net loads experienced after prestressing the rakers. The benefit of the rakers is very doubtful since the pattern of settlement and deflection continued to occur after the rakers were installed.

The choice of the assumed failure plane for design now appears invalid for Pearl Street when the additional thickness of the softer glacio-marine clay is considered. The upper tiebacks were not long enough to prevent a mass movement of the clay. By assuming a flatter failure plane ( $45^{\circ}$ ) it is apparent in Figure 10 that 15 to 30 percent of the upper four tieback anchors are located within the failure zone. Since the other side of the excavation did not experience similar magnitudes of deflection, the mass movement on Pearl Street is attributed to the thicker clay layer in the area where the ties are anchored.

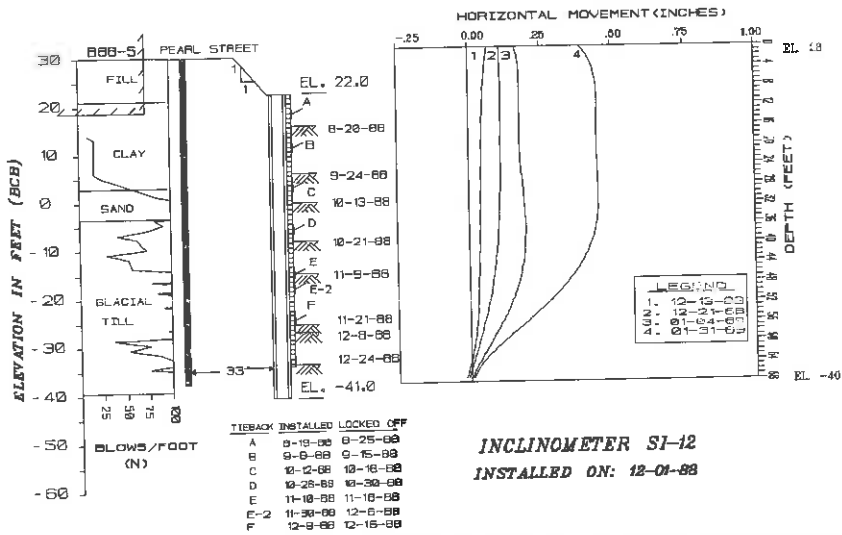
FIGURE 11a: LATERAL MOVEMENT OF PEARL ST. (33' OFFSET FROM EXCAVATION)

The inclinometers (SI 12, and SI 14) installed on the West side of Pearl Street, after movement problems developed, indicate lateral deflections of approximately 1/2 inch shown in Figure 11. The extent of the deflection shown in Figure 11 indicates that once the glacio-marine deposit began to move the till beneath was also mobilized to displace laterally. Thus, the mechanism of failure involves more than the clay sliding across the top of the till. This conclusion seems to be supported by the fact that the load cells on the lower tiers behaved similarly to the upper ones, i.e. no increase in load was associated with continuing lateral deflection.
