DEEP SOIL MIXED WALL AND JET GROUTING FOR AN EXCAVATION SUPPORT SYSTEM AT THE MUSEUM OF FINE ARTS IN BOSTON, MASSACHUSETTS

Harry Schnabel, P.E., Director of Business Development, Schnabel Foundation Co, Sterling, Virginia, USA

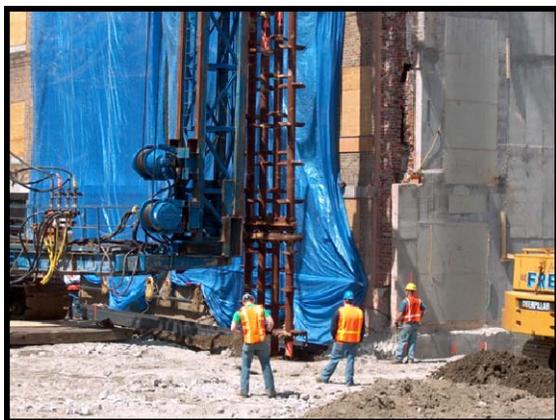
Figure 3 – Installation of Soil Mix Wall

Work proceeded in a continuous manner with around 15 m of wall completed on a typical day. In all, around 6,200 m² of CDSM wall was installed. Figure 3 shows the equipment used to construct the CDSM wall. The mixing paddles on the four auger shafts are evident in this Figure. This figure also shows the protective plastic sheet and plywood cover over the windows installed by the Construction Manager to protect the existing building from splatter caused by soil/cement falling off the augers. Figure 4 shows the cutting heads at the end of the augers.

The CDSM wall was constructed using multi-auger mixing equipment designed to mix an element of 4 soil-cement shafts in one stroke. Separate positive displacement pumps delivered the grout slurry through the center of the augers to the bottom of each shaft. Mixing paddles counter rotated and blended the cement grout slurry with the soil as the augers were inserted and extracted. The mixing shafts rotated at 12 RPMs on the down stroke and 24 RPMs on the upstroke and during re-stroking of the element. The mixing shafts were advanced at around 0.46 m per minute during the down stroke and 0.91 m per minute during the up stroke. Soldier beams were set in the semi-fluid soil-cement mix prior to initial set.
