"31st Annual Conference on Deep Foundations"

**EXCAVATION
SUPPORT AT THE
CAPITOL VISITOR
CENTER IN
WASHINGTON, DC**

Harald Ludwig, P.E., Ph.D

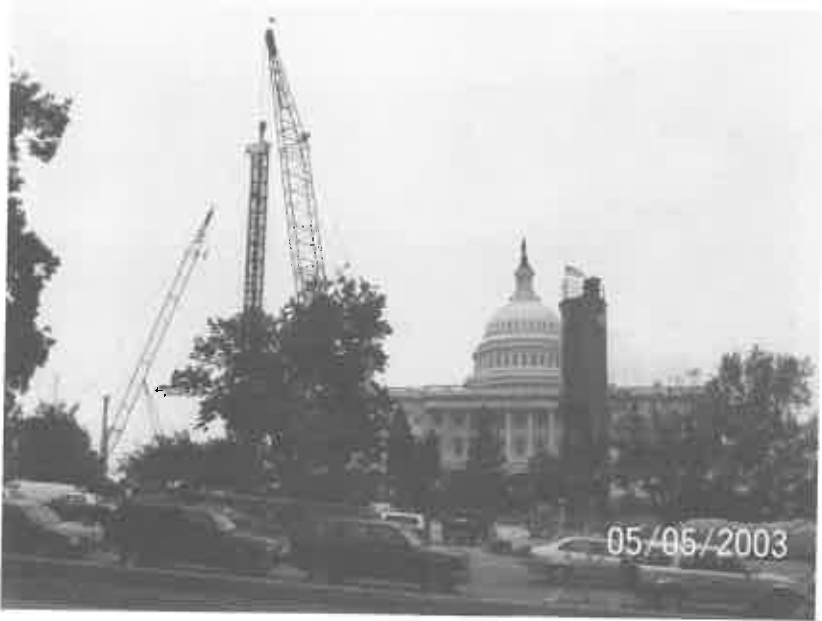
Figure 3- Deep Soil Mix (DSM) View with Capitol

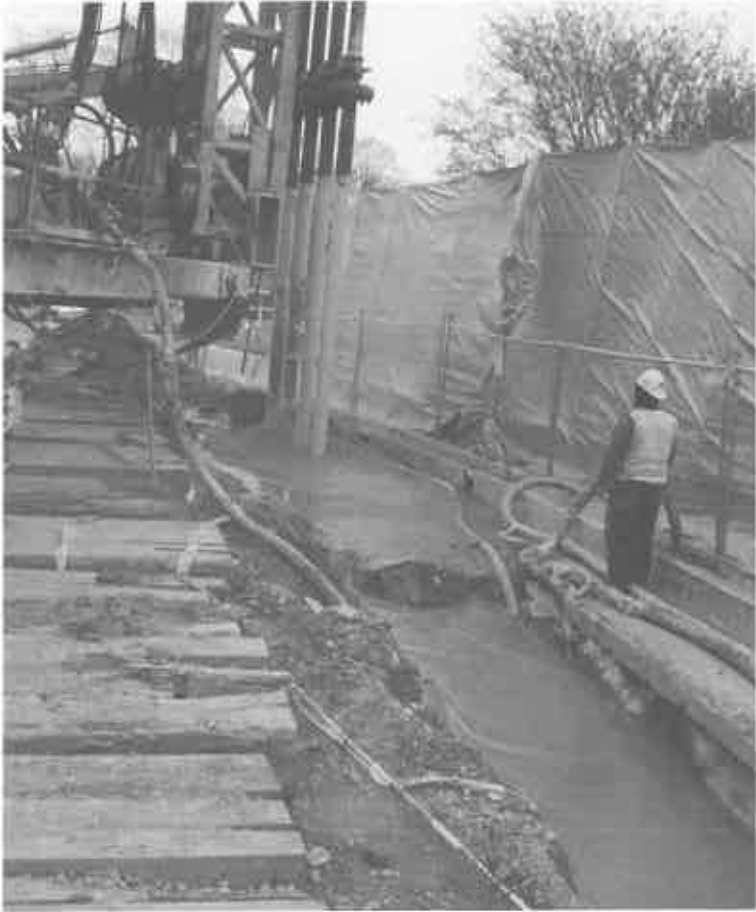
Figure 4 - Closer view of DSM Augers at Work

Deep Soil Mix (DSM) Portion: The DSM wall was constructed using the wet mixing method. The mixing tool consisted of four counter-rotating shafts. The shafts are equipped with a pilot bit and a short section of auger flighting at the bottom end to enable penetration into the soil. The remainder of each shaft is equipped with inclined mixing paddles. Each shaft has a hollow core through which neat cement grout is pumped out the bottom. The grout acts as a flushing medium during drilling by moving the soil cuttings away from the auger flights. The grout is then thoroughly combined with the soil cuttings as it passes by the mixing paddles. The mixing shafts create 36" diameter soil mix columns spaced on 27" centers.

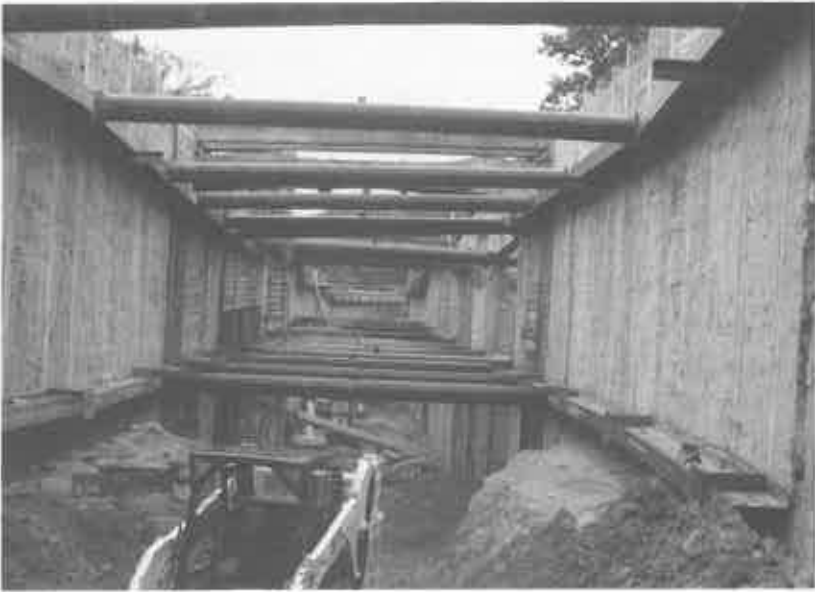
Figure 6 - Truck Tunnel Bracing at DSM

Steel pipe braces provided lateral support to the DSM wall as excavation progressed. Figure 6 below shows the two tiers of braces that were installed. The top tier braces were 18 in diameter spiral welded pipe with $\frac{1}{2}$ " wall thickness. The lower tier braces were 16 in diameter spiral welded pipe with 0.316" wall thickness. The braces had an average length of 30 ft and were not preloaded. The DSM wall transferred load to the braces through a continuous wale connected to each soldier beam.

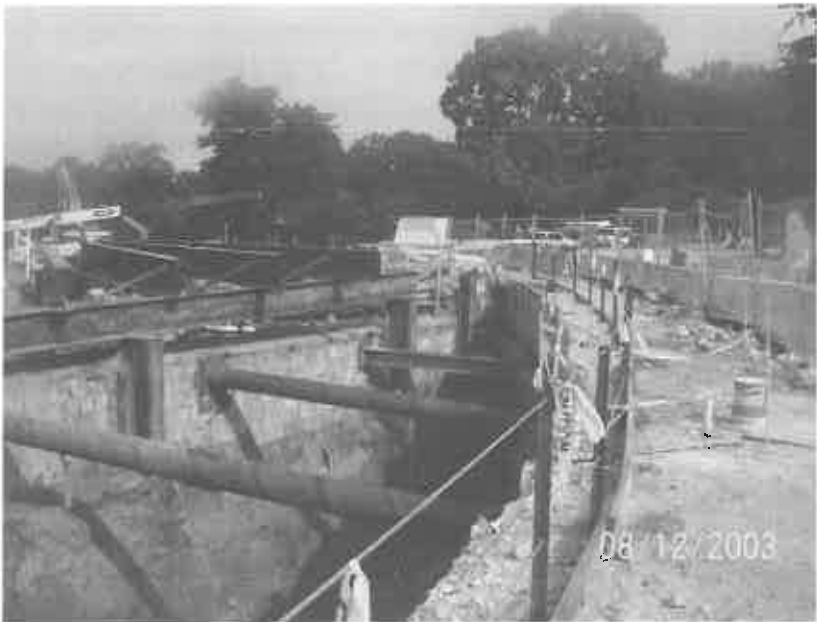
Figure 7 - Russell Tunnel Support System

this problem, a system of closely spaced beams below the overloaded "eggshell" floor were supported directly on piles or hung from structures that were installed above (See Figure 7). In order not to undermine too much of the floor at one time before the supporting beams could be installed, very careful hand excavation was required. The spoils were removed beyond the tight spaces below the tunnel via conveyor belts. Once this tunnel was successfully supported, the third challenge was to shore below it without overhead access to install piles. Due to these space and access constraints, a combination of reinforced horizontal concrete beams with tiebacks, shotcrete, and soil nails was designed and installed. This system shown below worked quite well.

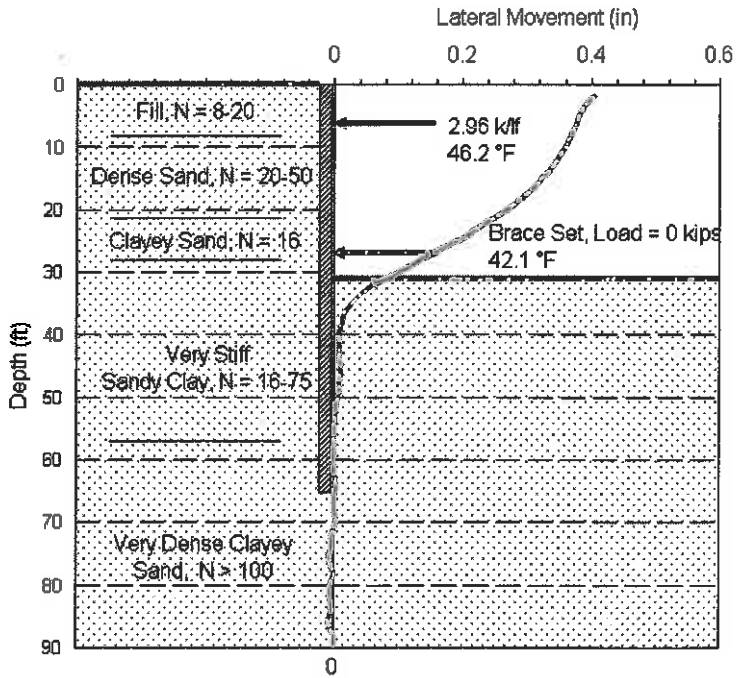
Fig. 8c - Lateral Movement and Brace Load - Day 218

The movement of the DSM wall at various stages of excavation is illustrated in Figs. 8a-8d. The inclinometer casing embedded in the soil mix was used to plot movement. The two inclinometer casings were in close agreement with each other. The locations of the lateral braces are also shown, as well as the temperature of the braces and the total brace loads measured by the strain gauges. The total brace loads include earth, water, and surcharge pressures, as well as any temperature induced loads due to thermal expansion or contraction of the steel brace. It was not possible to separate the temperature induced loads from the total loads because an inadequate number of readings were taken. This prevented the development of an accurate temperature adjustment. Nevertheless, it is possible to make qualitative observations of the behavior of the wall and braces based on total brace loads and measured brace temperatures.

The measured total loads in the top braces on Days 126 and 218 are lower than expected. The brace temperatures on these days were 34F and 52F lower, respectively, than when the braces were installed. Although we are unable to accurately estimate the temperature induced loads, it is believed that thermal contraction of the steel contributed to the low total load.
