"30th Annual Conference on Deep Foundations"

UNDERPINNING
HISTORIC MUSEUM
FOR U-505
SUBMARINE
RELOCATION

UNDERPINNING HISTORIC MUSEUM FOR U-505 SUBMARINE RELOCATION

Mark R. Goudschaal, Schnabel Foundation Company,
Cary, IL, USA

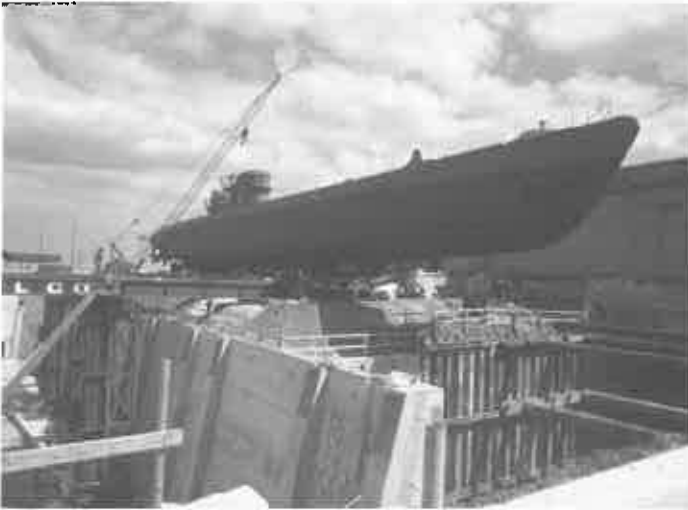
Figure 1: U-505 Submarine Ready for Launch

The historic U-505 German submarine at the Museum of Science & Industry was restored, moved approximately 1,000' and then lowered into its new indoor home (Figures 1, 2 and 3). The new underground exhibit opened this year celebrating the 61st anniversary of the German submarine's capture on June 4, 1944. On this historic day, Captain Daniel V. Gallery, a Chicago native, led the Navy in the siege of this submarine near the coast of Africa. This U-boat was the only German sub captured by the United States Navy in WWII and the Enigma machines, codebooks and publications recovered from the sub helped the war effort.

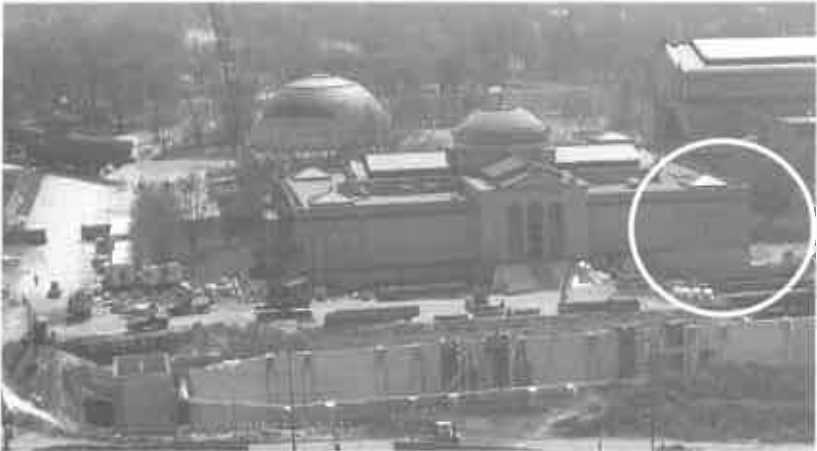
Figure 2: U-505 New Underground Exhibit and East Pavilion Underpinning Area (circled above)

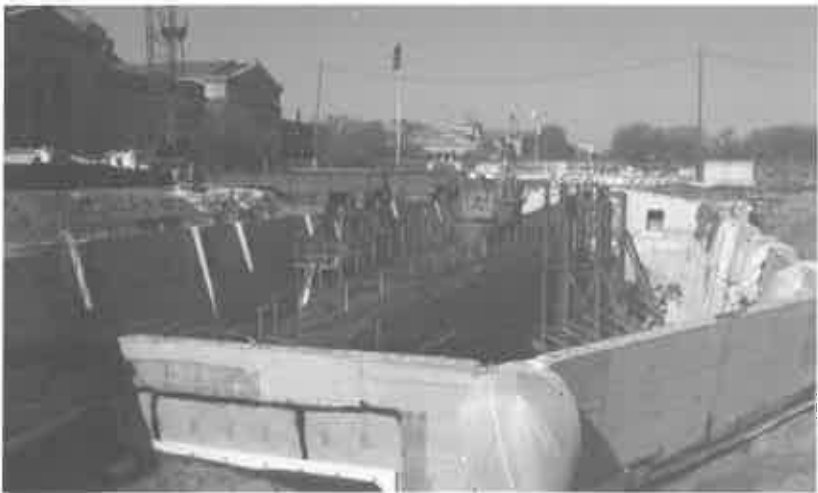
Figure 3: U-505 Submarine - New Exhibit Area

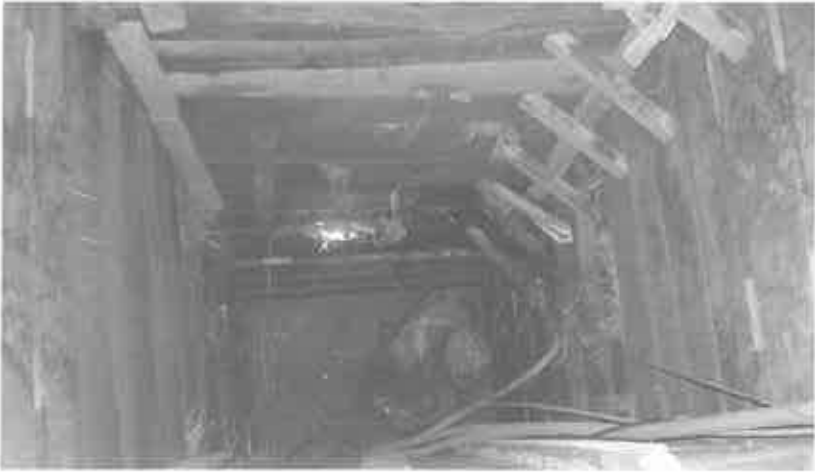
Figure 6: Underpinning Pier Construction

Hand-dug concrete piers (Figures 6 and 8) were designed for combined axial and bending stresses. Allowable bearing pressure for the hand-dug concrete piers was 8 ksf, as stated in the geotechnical report prepared by Ground Engineering Consultants, Inc. Underpinning piers extended from the bottom of the existing footings (El. +2 CCD) to below the bottom of the new elevator mat foundation.

- Dewater utilizing well points in close proximity to north wall footing.
- Hand-dug underpinning piers (Figure 6).
- Walers and cross-lot braces in Link Area.
- Link and East Pavilion excavation and shotcreting in lifts inside building.
- Tiebacks, wales and braces installed during excavation in lifts (Figure 14).

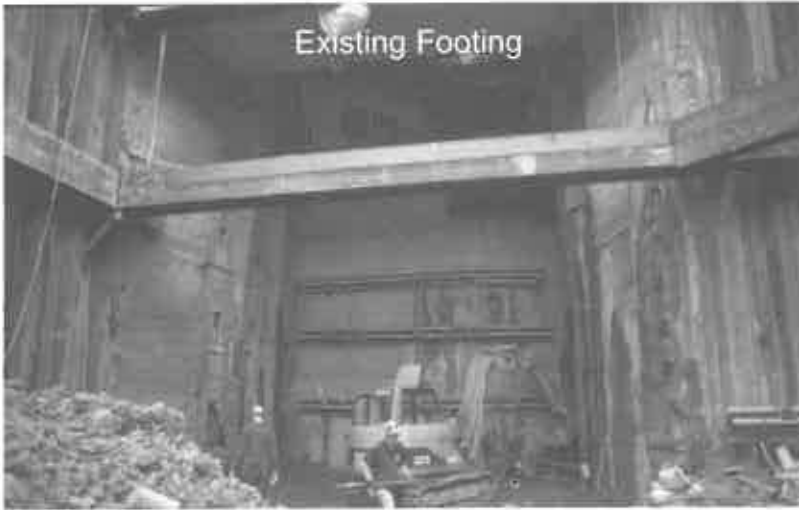
Figure 7: East Pavilion - Excavating to final tieback tier in new elevator & stairwell area.

East, west and south walls of the excavation for the new elevator and stairway under the East Pavilion were supported using tieback walls (Figures 7 and 8). The hand-dug concrete underpinning piers acted as the vertical elements for the east and west walls. Permanent tiebacks were installed through the concrete underpinning piers (Figure 8).

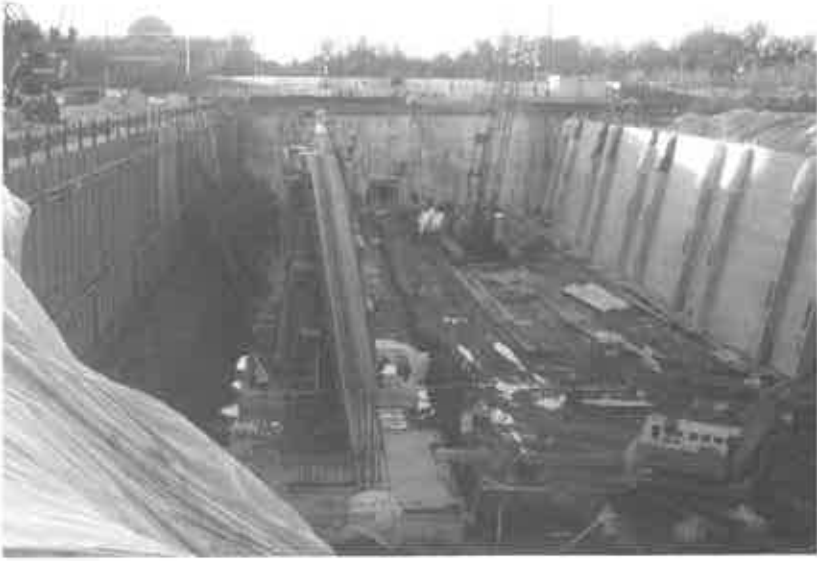
Figure 10: Sheet pile south wall - New Exhibit Area

Extending north from the East Pavilion underpinning area, braced and tieback sheet pile walls were designed and constructed for excavation of the link and new U-505 exhibit area (Figures 4 and 10).

Due to a conflict with the permanent tiebacks supporting the existing underground parking garage, the sheet pile on each side of the new link was internally braced. Sheet pile along the south side of the new exhibit area - shown in Figure 10 - was installed as part of a separate contract for Lake Shore Drive improvements. Since the sheet pile sections were only driven a short distance into the hardpan, this south wall had to be laterally supported by tiebacks and designed for excavation below the tip elevation.

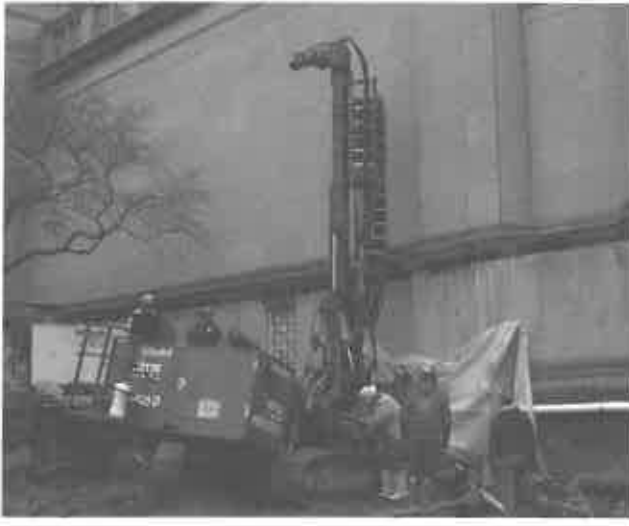
Figure 11: Installing Micropiles for PT Beam

- Steel sheet pile installation in Link Area.
- Jet grouting inside and outside of East Pavilion building (Along west, south and east existing footings).
- Micropiles drilled inside and outside the existing structure (Figure 11).

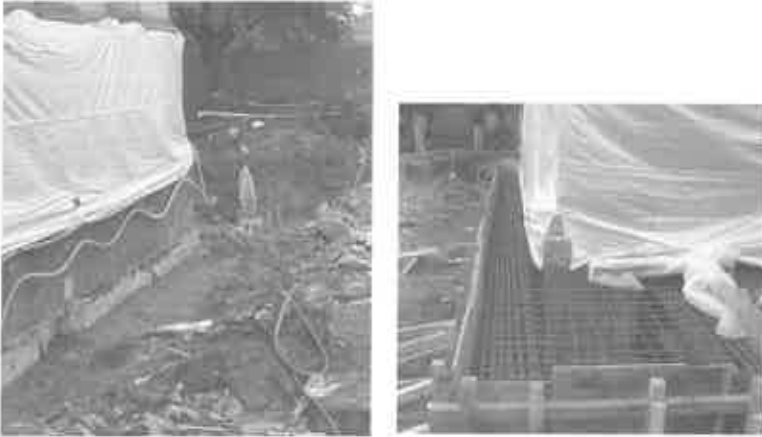
Figure 13: North Wall footing exposed (Left) and PT beam reinforcement (Right)

- Excavation for and construction of concrete post-tensioned transfer beam to support East Pavilion north wall in the final design condition (Figures 12 & 13).
- Reinforced concrete micropile caps (Figure. 9).

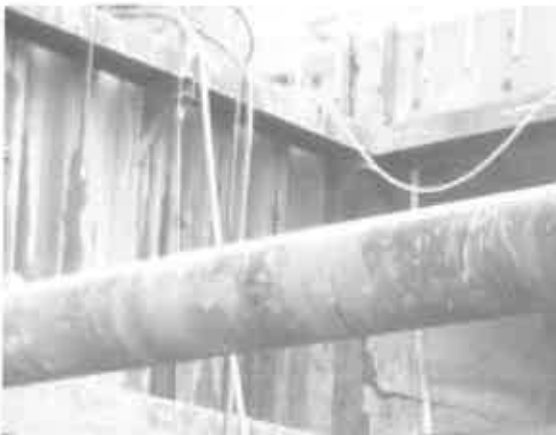
Figure 14: New Link and East Pavilion Area Excavation, Braces and Tieback Construction

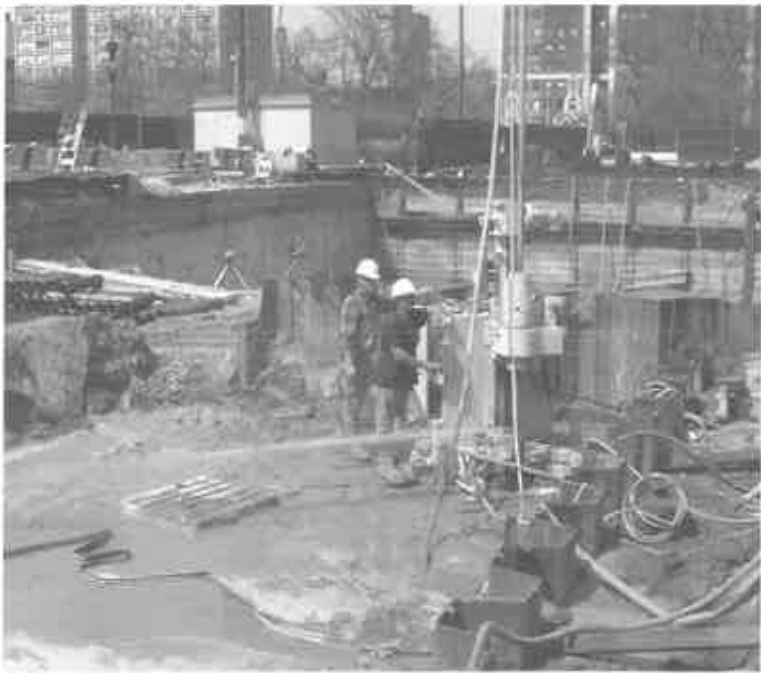
Figure 15: Jet grout test section - Link Area

Prior to the start of the work, a jet grout test section was completed, partially exhumed and examined to evaluate the performance (Figure 15). The double tube jet grout system was chosen based on the test section performance of sequential interlocking columns. A total of six (6) test columns provided the data required to verify the correct jet nozzle, rotation and withdrawal rate, column diameter, column overlap and water-cement ratio. The column diameter was 3.5 feet with depths as much as 21 feet.

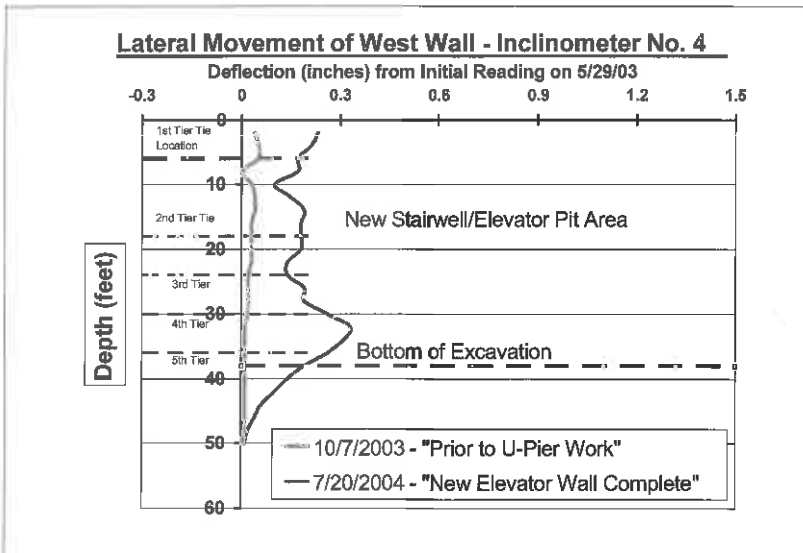
Figure 17: Lateral Movement of East Pavilion

The monitoring results are summarized by Figures 17 and 18 for the lateral and vertical movements. The maximum inclinometer lateral movement was 0.33" and vertical movement was 1" upon completion of project. The maximum vertical movements of the north exterior and east interior walls were 0.875" and 0.75", respectively. As noted earlier, the contract settlement limit was 0.75".

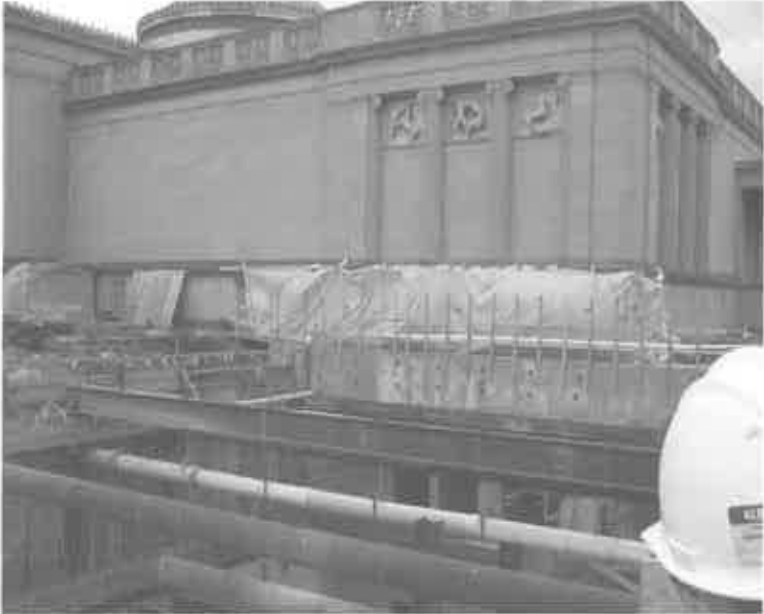
Figure 19: New Elevator & Stair CIP Walls Complete

The revised construction procedures resulted in additional vertical movement of 0.25" (from June 24, 2003 until project completion). The East Pavilion west wall vertical movement was 0.75" prior to underpinning work and 1" upon project completion (Figures 19 and 20). The north and east wall settlement was slightly less than the west side. Due to the gradual nature of the settlement shown by the monitoring data, there was no widening of existing cracks or building distress observed.

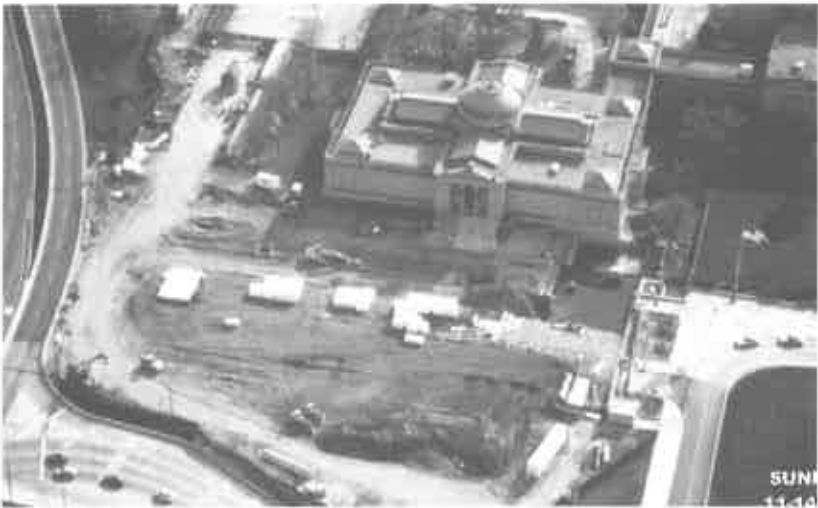
Figure 20: New Exhibit Area backfilled and Link roof water-proofing test underway
