SCHNABEL DESIGNED & INSTALLED SHORING AROUND THREE ADJACENT SENSITIVE & HISTORIC STRUCTURES IN WASHINGTON, D.C.

Shoring Around Sensitive Structures

Shoring and Deep Foundations Around Sensitive Structures in Washington, D.C.

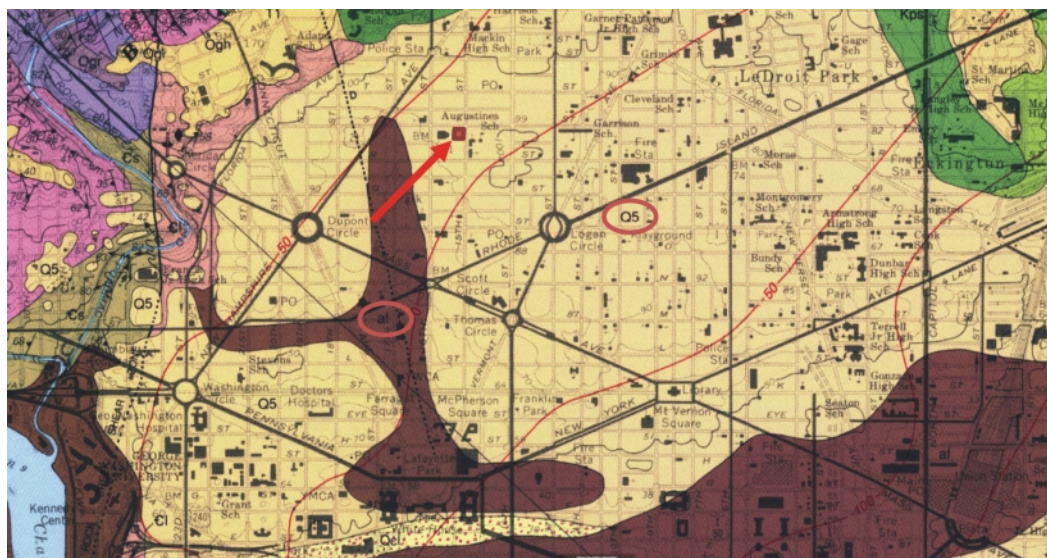
Q5: Gravel, sand, silt and clay. af: Artificial fill

The soils at this project site are typical for northern downtown Washington, D.C. Upper soils consist of man-made fill overlaying alluvium deposits. The alluvial river deposits consist of loose to medium dense sands, silts and gravels, and are approximately 25 ft (8 m) thick with blow counts in the single digits.

Below the alluvial layer, Cretaceous age marine deposits from the Potomac Formation are present. The Potomac Formation deposits are stiff to hard clay

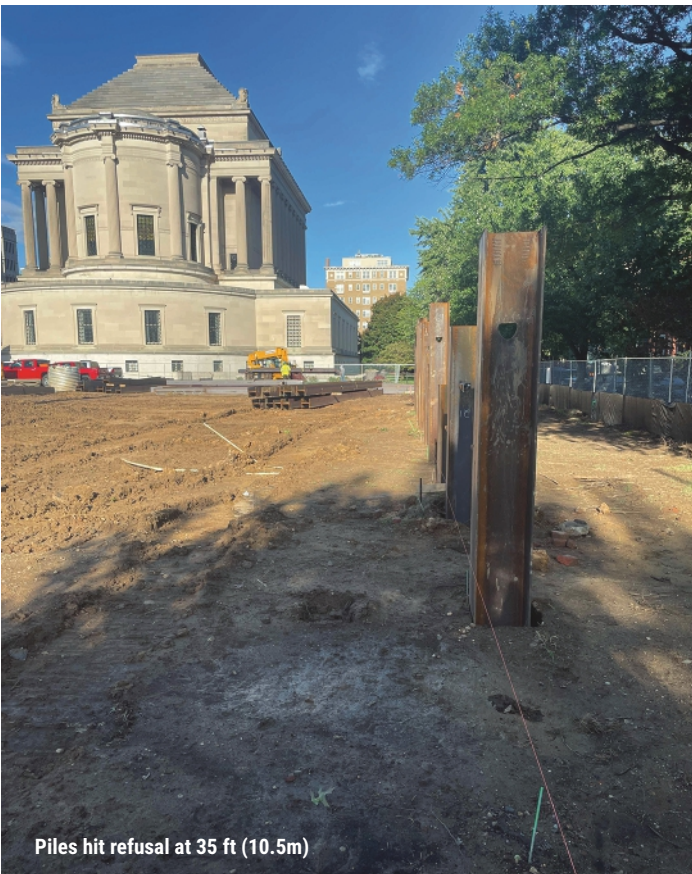
Piles hit refusal at 35 ft (10.5m)

Initially, soldier pile installation by drilling was specified due to concern over vibrations. Schnabel proposed driving soldier piles using a variable moment hammer to limit installation vibrations. The design team, including design consultants for the House of the Temple, permitted all 115 soldier piles to be driven with real-time continuous vibration monitoring performed at all adjacent buildings. At the House of the Temple, vibrations were minimal with readings of 0.01-0.05 in/sec (0.25-1.27 mm/sec) recorded at distances of 50-100 ft (15-30 m) from the soldier pile operation. The vibrations peaked at the carriage house and Campbell townhouse structures while the soldier piles were penetrating a stiff layer of soil. During these peaks in vibration, the existing cracks on the structures were monitored in real time. Installation proceeded while closely observing the penetration rate of the pile and the existing conditions of the structures. Schnabel allowed piles that hit refusal

to sit overnight and drove them to design depth with less difficulty and lower vibrations the next day. One possible explanation for this phenomenon is that groundwater was able to percolate along the sides of the soldier pile and loosen the salt bonds in the cemented sands allowing additional driving the next day. No new cracks developed on the existing structures and existing cracks did not propagate or widen during soldier pile driving.

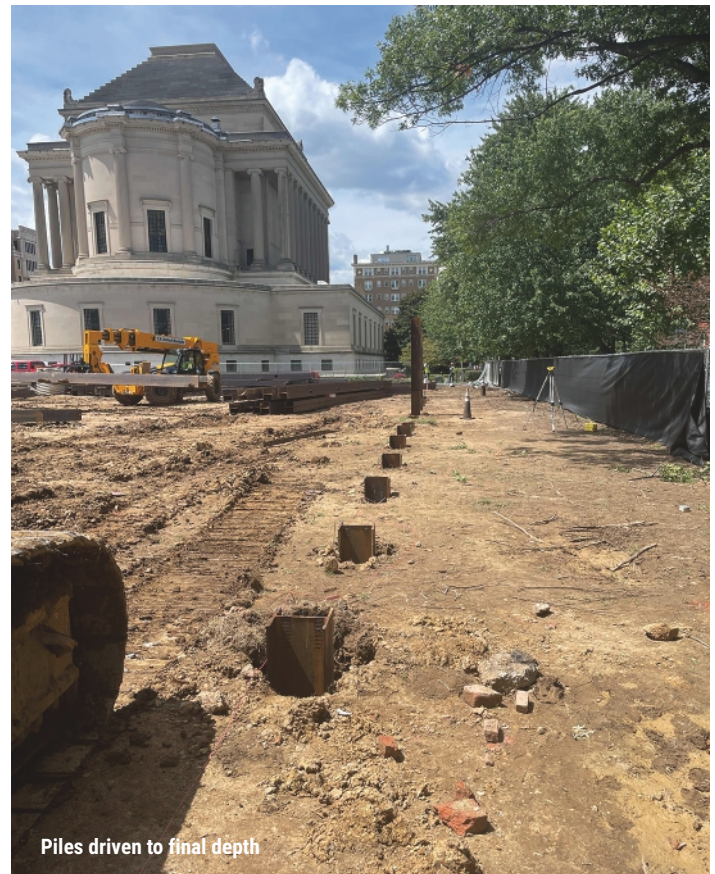
Piles driven to final depth

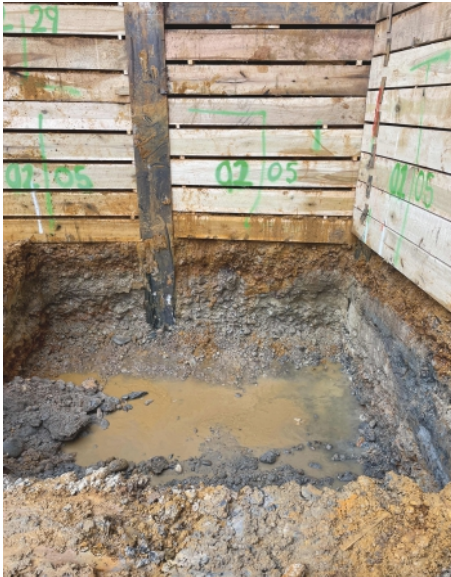
Change in strata at cemented sands

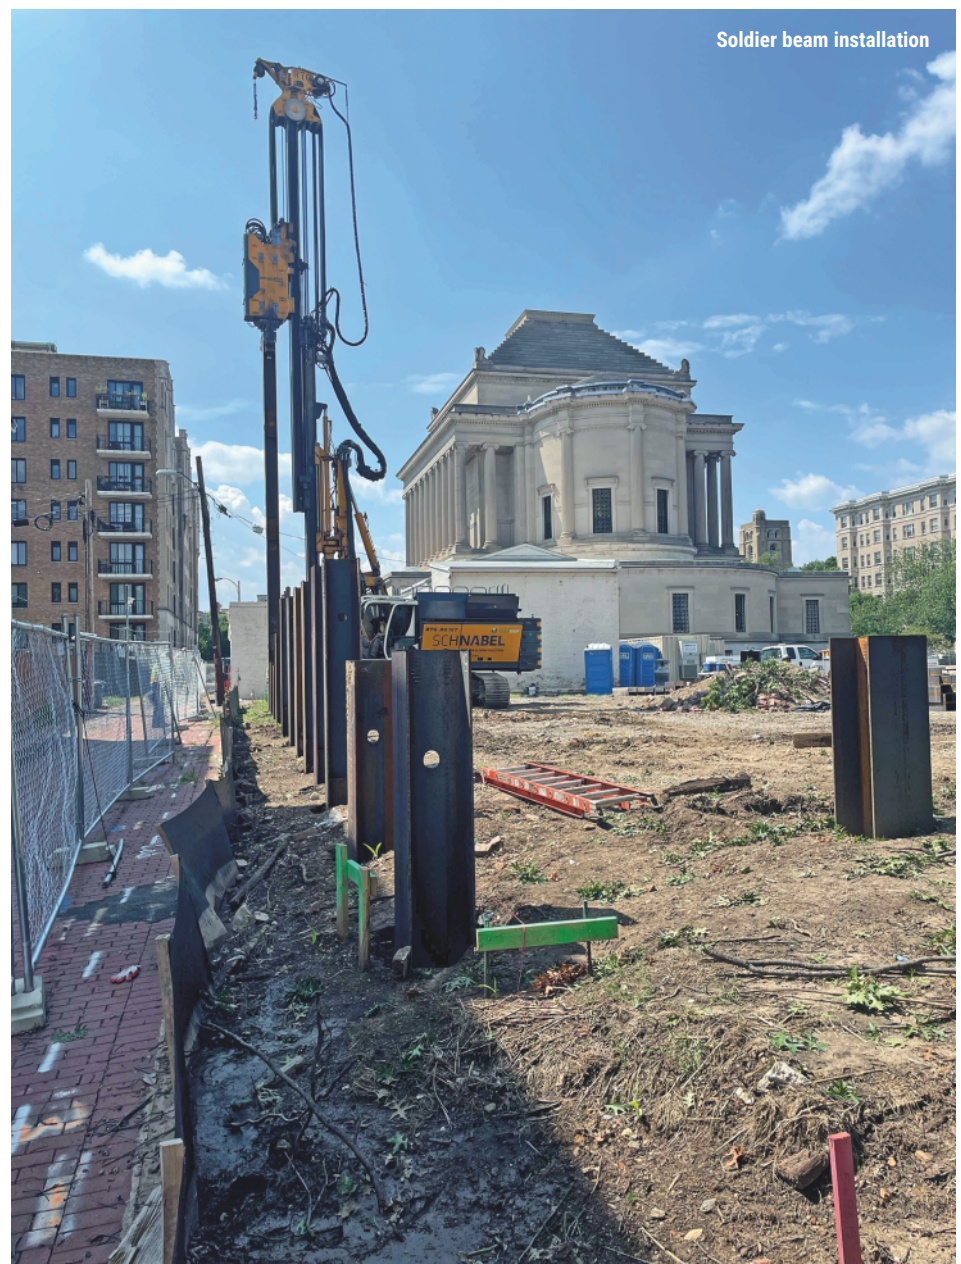
The project structural drawings showed 28 micropiles spread out over five pile caps in the English basement

level. The micropile design load was up to 171 kip (760 kN) in compression. Micropiles were installed using the same method used to install the tiebacks. As with the tiebacks, a down-the-hole hammer was used to penetrate through cobbles and boulders and the micropiles were regouted to ensure bond capacity. The micropile design load was carried by a solid bar tendon in the center of a 7 in (179 mm) diameter hole. Permanent casing was used in the upper 20 ft (6 m) of the micropile to locate the bond zone of the micropile below the lowest subgrade elevation for the project.

To aid in the design of the micropile bond length, an eight-strand “tieback” was installed vertically and tested in tension to its maximum structural capacity of more than two times the micropile design load. Based on this preliminary test, an allowable bond stress of 30 psi (0.2 MPa) was assumed for micropile bond design resulting in a bond length of 25 ft (8 m). In accordance with ASTM D3689, a nonproduction micropile load test was performed to two times the micropile design load with satisfactory results.

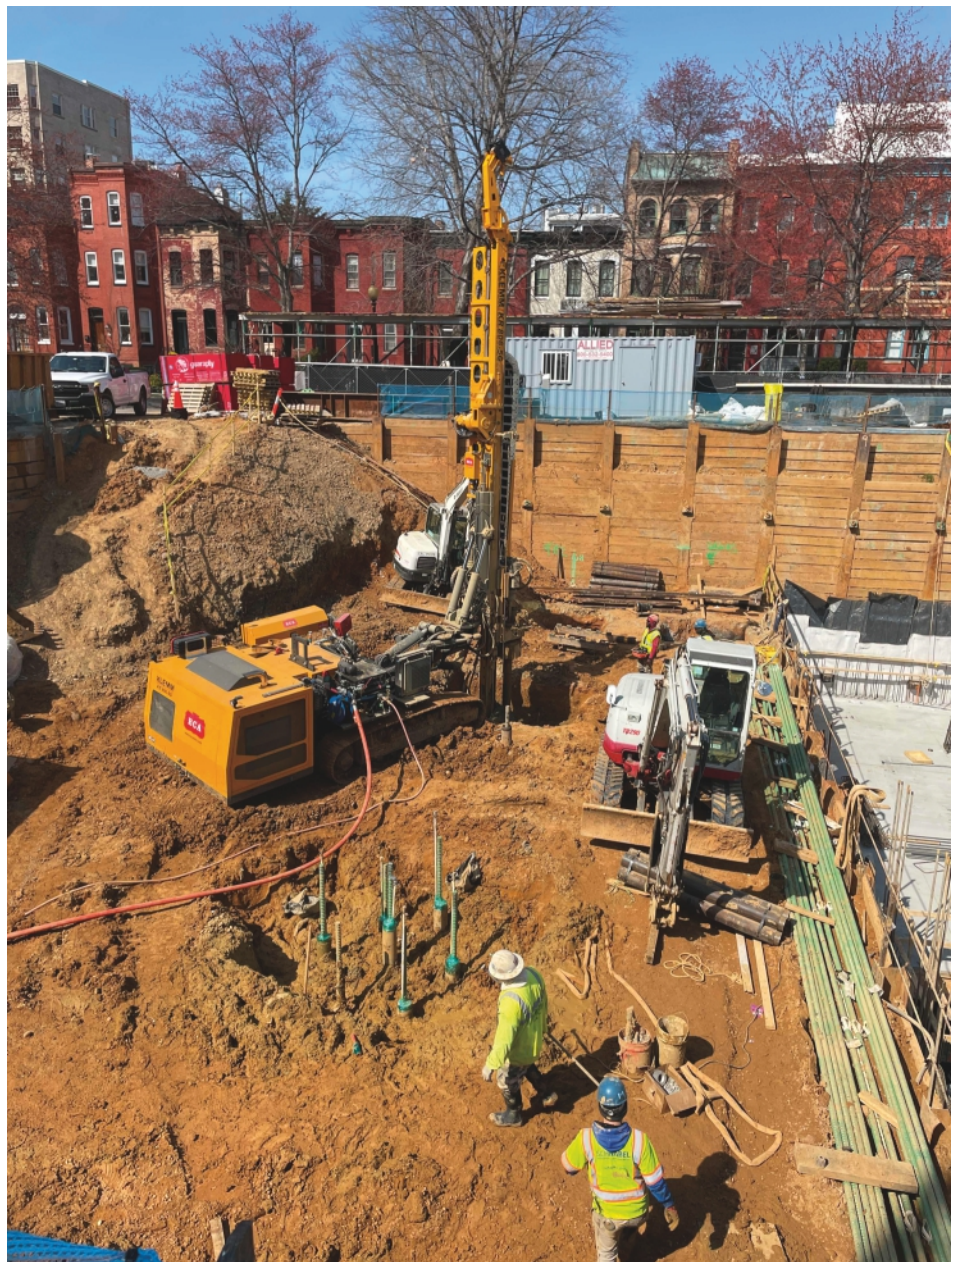
Micropile set up
