# CAL POLY SLO LANDSLIDE REPAIR

## San Luis Obispo, California

### BACKGROUND

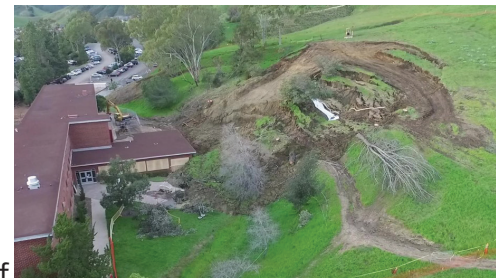
Landslide running into the Fremont Dorm

In 2017, California was hit by unusually high seasonal rains propagating landslides up and down the state. One of the most notable landslides that year was the mud creek landslide that buried a quarter mile of the pacific coast highway. Although it wasn't as big, another landslide occurred in 2017 on the Cal Poly San Luis Obispo Campus. The slide ran into the Fremont Dorm on Campus in February of 2017 causing an immediate evacuation of the dorm in the middle of the school year. The dorm has not been occupied since.

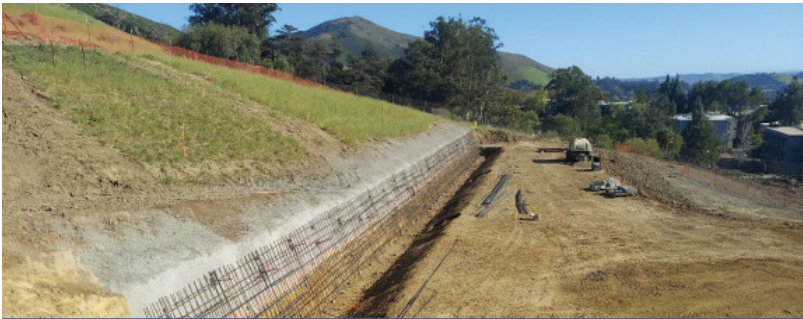
gallery wale construction

The construction phase of the project began in August of 2021 and was completed in May of 2022. Schnabel self-performed all the gallery wale construction and tieback drilling work. The grading contractor on the job was Raminha who was responsible for grading the gallery benches and wall slopes. The gallery wales are at a 20-30 degree back slope and range from 8 to 10 feet in height requiring temporary shoring to be installed. To ease construction and save time, fiber-reinforced shotcrete was used in lieu of wire mesh as reinforcement for the temporary soil nail facing. Once the temporary shoring was installed, the wales were tied and shot with tieback block-outs to be drilled.

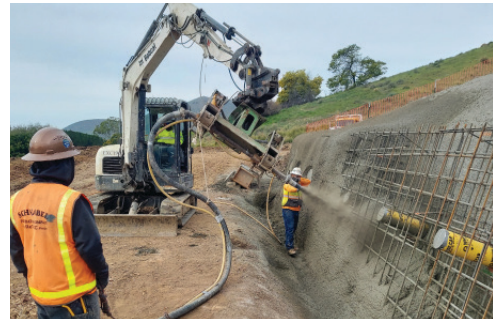
applying shotcrete to the gallery wale

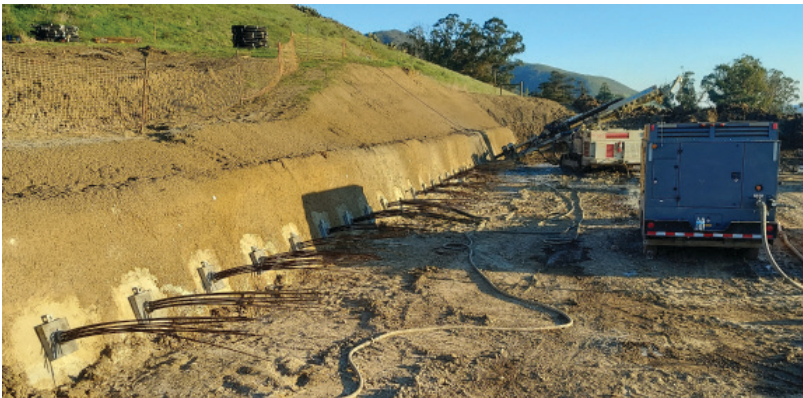
tieback drilling with 178 mm casing

The tieback drilling was performed using an under-reaming bit system with 178 mm casing. The casing is drilled to rock through the overburden landslide material and the rock is then drilled for the bond length of the tiebacks. The tiebacks range in total length from 80 feet to 124 feet with unbonded lengths ranging from 40 to 84 feet. The tiebacks are on nominally 5-foot centers which required that the drilling setup and alignment be performed with great care to not hit previously installed tiebacks.

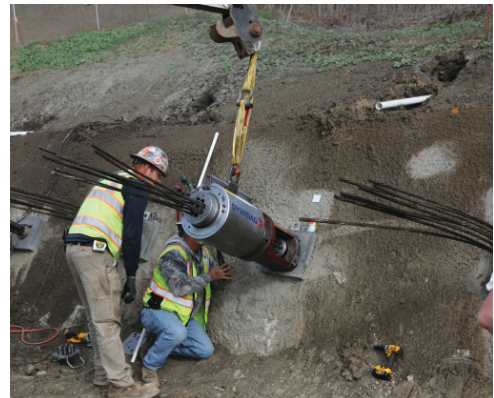
tieback testing
