## Trinity Church Boston, MA

Boston's historic Trinity Church recently underwent a renovation and expansion that included an innovative foundation repair and replacement system that was designed and installed by Schnabel Foundation Company. Schnabel repaired a number of the existing timber piles and installed new grouted steel micropiles to allow the renovation and expansion to be successful.

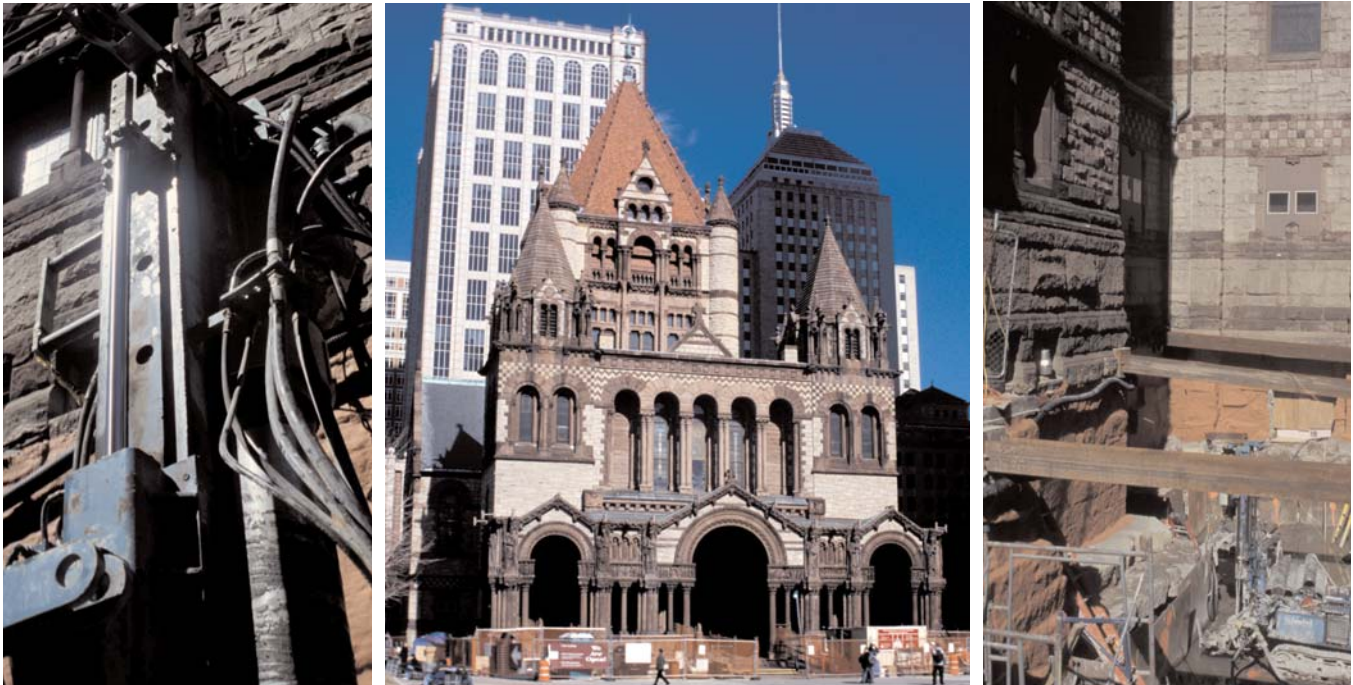
Micropiles were installed in the basement of the church and around the perimeter of the building (20 ft. below street level) using a special drill constructed to be used in limited access applications. The drill rig can be lifted in place by a crane and driven through doorways and hallways. The small but powerful drill rotated 10-inch casing through caving soils and timber pile obstructions to reach a suitable bearing stratum.
