MICROPILES

TRINITY CHURCH - BOSTON, MASSACHUSETTS

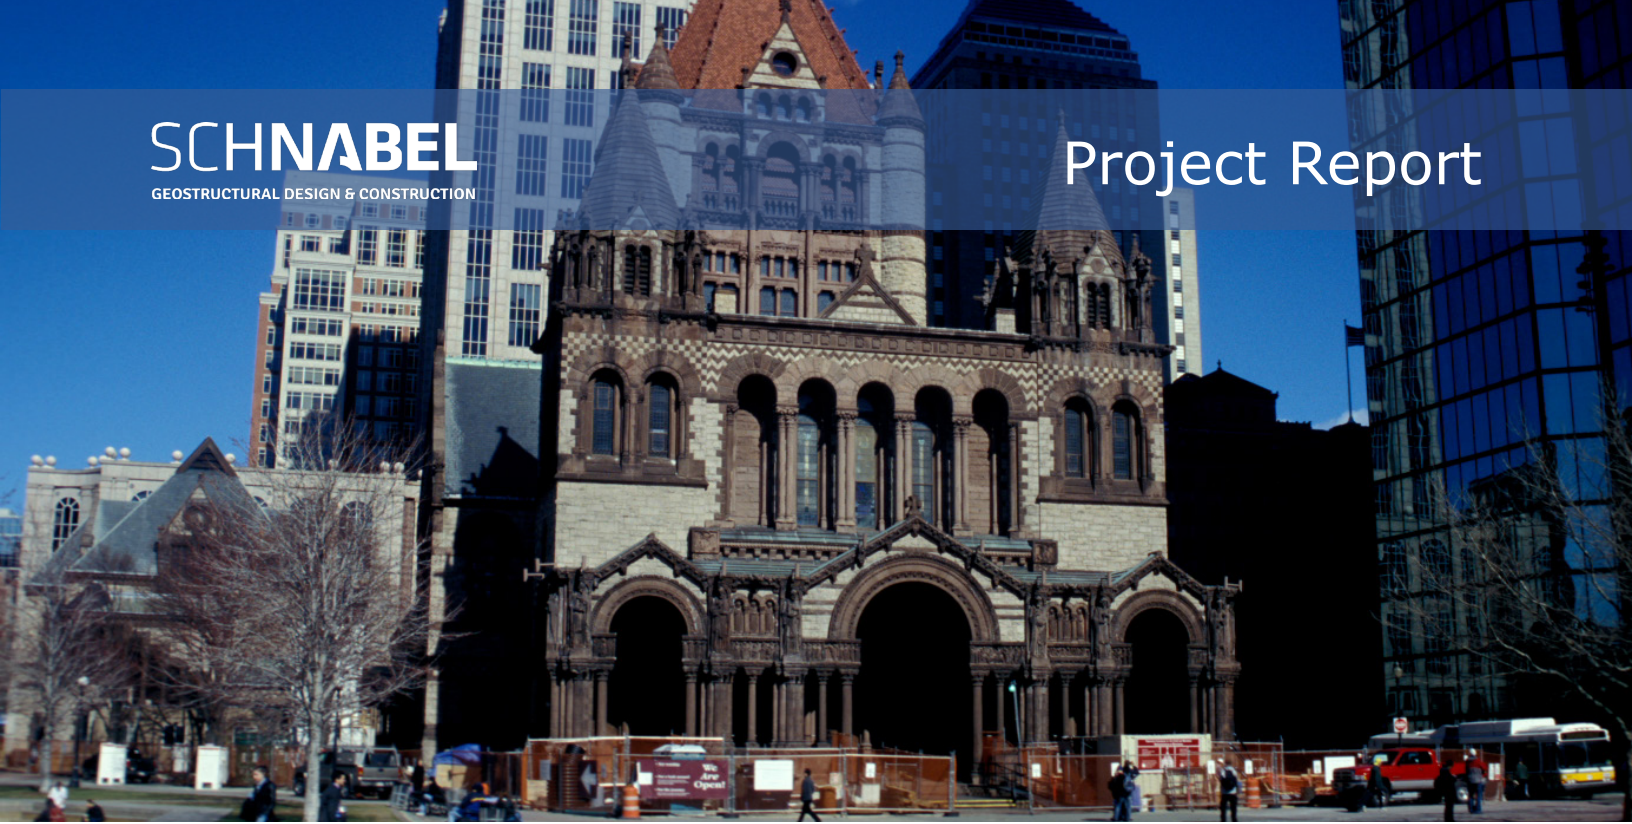
The Trinity Church is well known Historic Landmark in downtown Boston. Lowering of the water table from numerous construction projects and deep basements has resulted in the deterioration of the wood pile foundations that support many of Boston's Historic Structures. At Trinity Church, Schnabel both repaired the existing wood piles and installed new micropiles.

Schnabel began the repair work by carefully hand excavating around the pile tops. Temporary supports were then placed beneath the huge granite block foundations supported by the piles. The rotted pile tops were then cut away and replaced with steel struts and the entire excavation filled with lightweight concrete.

Micropiles were installed in the basement of the church and around the perimeter of the building (20 ft below street level) using a small drill for use in limited access applications. The drill rig can be lifted in place by a crane and driven through doorways and hallways. The small but powerful drill rotated 10-inch casing through caving soils and timber pile obstructions to reach a suitable bearing stratum.
