MICHIGAN STATE CAPITOL STATE HERITAGE HALL

Lansing, Michigan

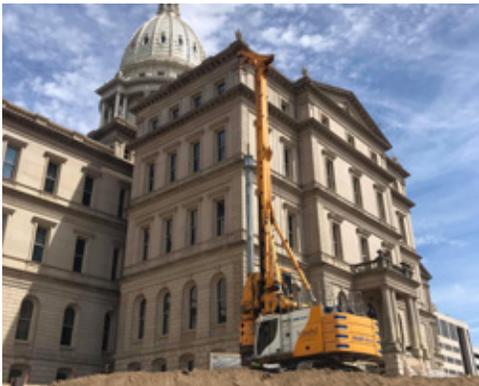
Bauer BG-26 Drill Rig

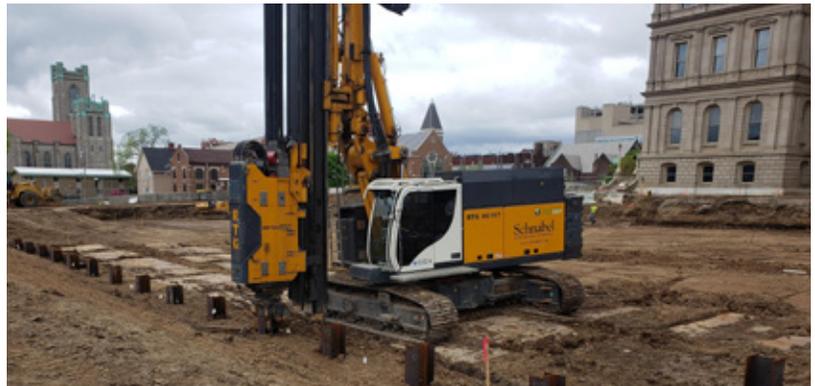
Installing the Secant Wall Several Feet from the Capitol Building

Schnabel was brought on to the project to provide both temporary and permanent excavation support. The average depth of excavation was 26 feet with up to two levels of tiebacks. A permanent secant wall with tiebacks was selected to control horizontal and vertical movements where shoring was required within the zone of influence of the Capitol. Temporary excavation support consisting of driven soldier piles, lagging, and tiebacks were used in all other areas away from the Capitol.

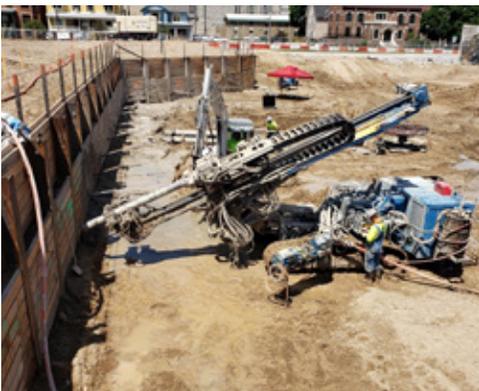
Tieback Installation

The tieback operation also had its own set of challenges. Tiebacks were installed around an array of newly installed geothermal wells. Every geothermal well within the tieback length was field verified to ensure our tiebacks would not conflict. The project also had two interior corners where tiebacks crossed. Careful drill alignment was required to weave the tiebacks between geothermal wells and other adjacent tiebacks. The project was completed in September 2020 without exceeding the movement criteria of the Capitol or any of the excavation support. Tiebacks were successfully installed without striking any of the geothermal wells. The project was completed on time to the satisfaction of our client. Special thanks to everyone involved in this project.

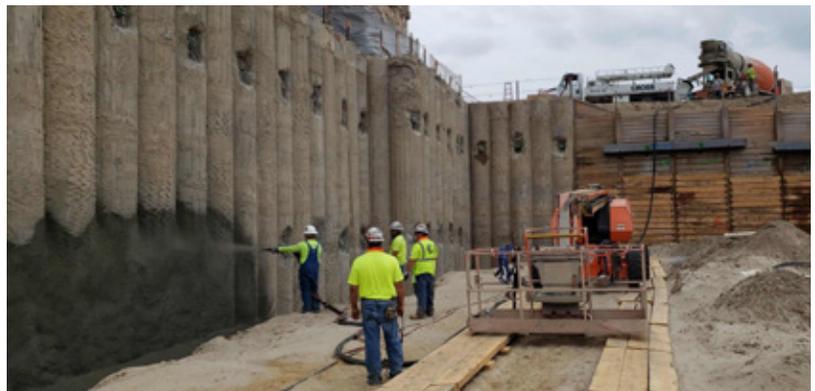
Applying Shotcrete to the Secant Wall
