U.S. 42 in Gallatin County

On June 9, 2021, Schnabel was awarded the \$18M Gallatin County Slide Repair project as the prime contractor for the Kentucky Transportation Cabinet (KYTC) Department of Highways. The project is a 1.25 mile-long reconstruction of U.S. 42 located roughly half way between Cincinnati, Ohio and Louisville, Kentucky. U.S. 42 is a two-lane scenic highway which runs along the Ohio River. This section of the highway has been prone to landslides since it was built. Work began on the project in November of 2021.

As part of the Gallatin County Slide Repair project, Schnabel is constructing a 0.6 mile long tieback retaining wall to help stabilize the existing landslides. Schnabel designed the wall using KYTC apparent earth pressure and toe embedment parameters. The wall has one to two-tiers of tiebacks with 385 double wide-flange soldier beams, 540 each 10-strand fully encapsulated tiebacks, 75,000 square feet of temporary lagging, and 65,000 square feet of precast concrete panels.

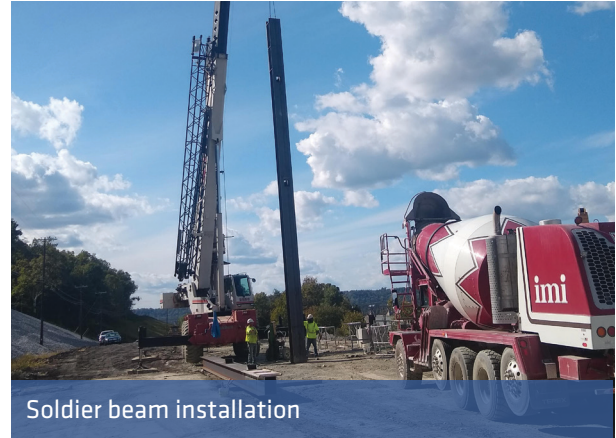
Soldier beam installation

Schnabel experienced several complex challenges on this project. During the utility relocation work, the landslide continued to move, resulting in additional displacements of around one inch per month prior to the soldier beam installation. In addition, the lack of suitable survey control points made it difficult to monitor landslide movements.

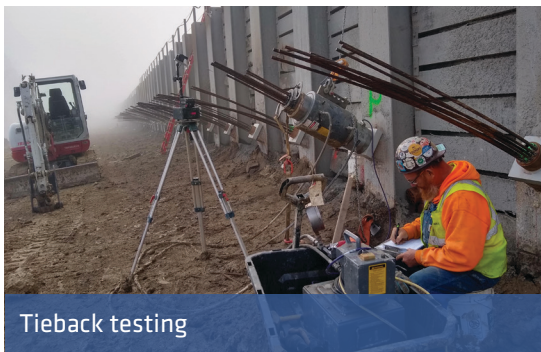
Tieback testing

To assist with monitoring, eight inclinometer casings were installed in SB drill holes. These have been manually read since inclinometers are more reliable than our survey monitoring data. Another problem we encountered was the initial stressing of the tiebacks, which resulted in around five (5") inches of movement at top of the beam. Schnabel Senior Geostuctural Engineer, Doug Hardin brainstormed solutions for this problem and settled on installing diaphragm walls perpendicular to each soldier beam. These concrete-filled tranches resisted wall

movement by increasing sliding friction and bearing behind the soldier beam tops. This solution reduced the movement of the soldier beam tops to around 1.5" allowing for precast panel installation.
